# **Rockfall Hazard Condition at Makena State Park Maui, Hawaii**

Earth Tech, Inc.  
841 Bishop Street, Suite 500  
Honolulu, Hawaii 96813-3920

October 30, 2006

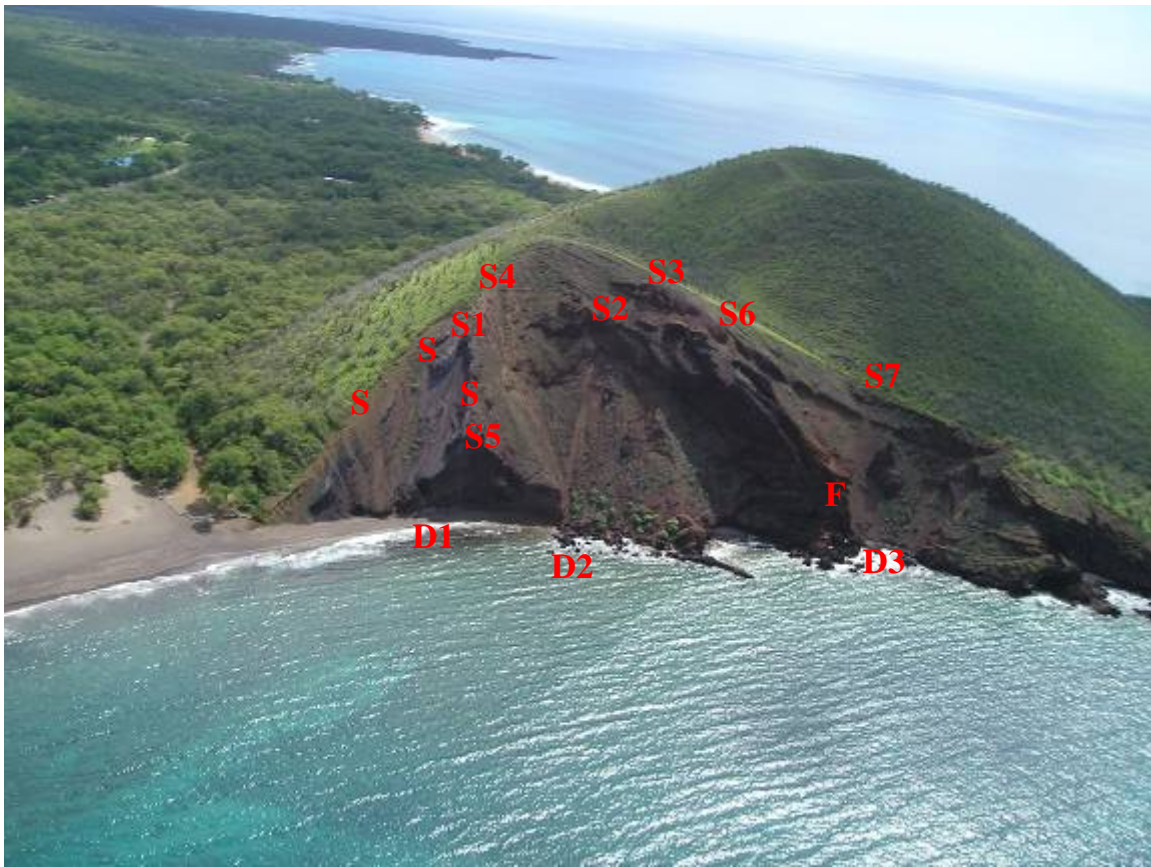
Significant rockfalls occurred along the rock cliffs at Makena State Park after the October 15 earthquakes, with at least ten easily recognizable rockfall sources, eight of them at Black Sand Beach (Photo 1), two at Big Beach (Photo 2), and none at Small Beach.

Photo 1. Sources of rockfalls, indicated by S in the photo, on the rock cliff at Black Sand Beach, Makena State Park.

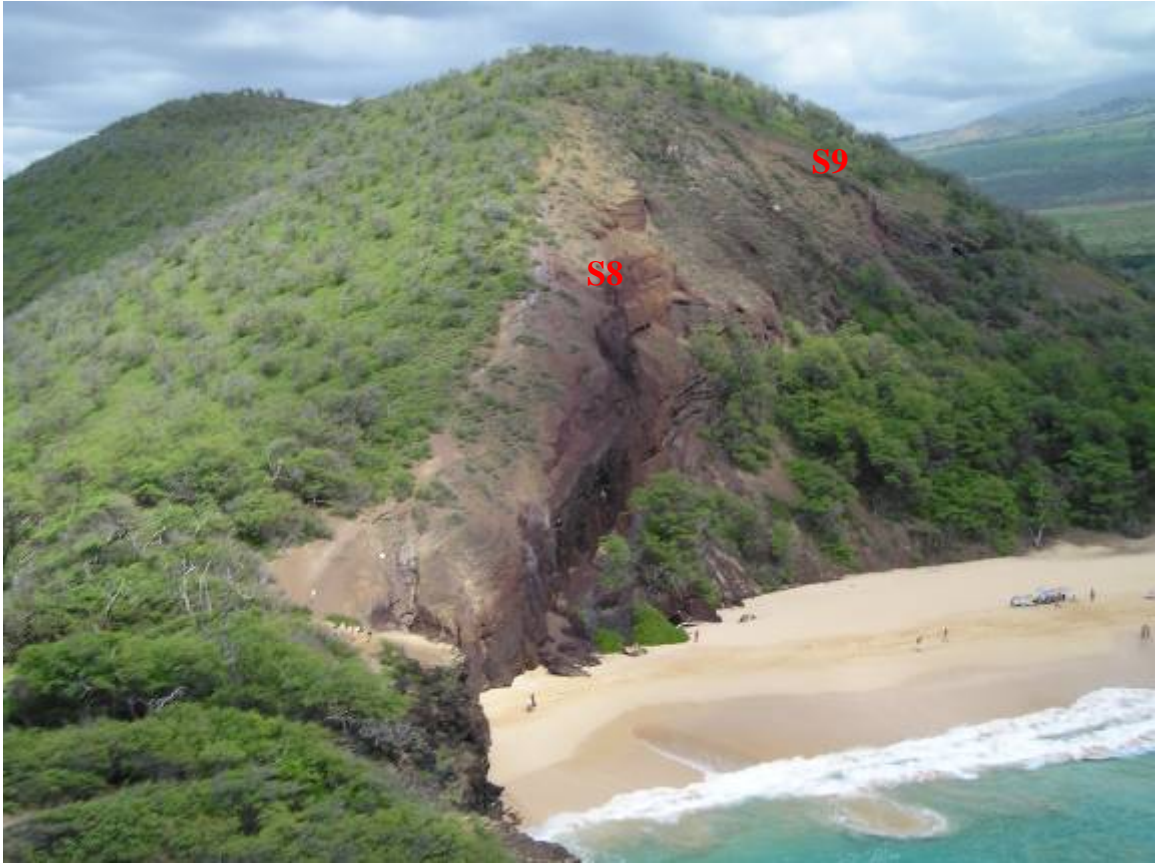
At Big Beach, only portions of the wide beach could be reached by rockfall debris of small loose cinders (Photo 8) and large cinder blocks (Photo 11). Most parts of Big Beach are safe in case of rockfalls (Photo 2).

Photo 2. Sources of rockfalls, indicated by S in the photo, on the rock cliff at Big Beach, Makena State Park.

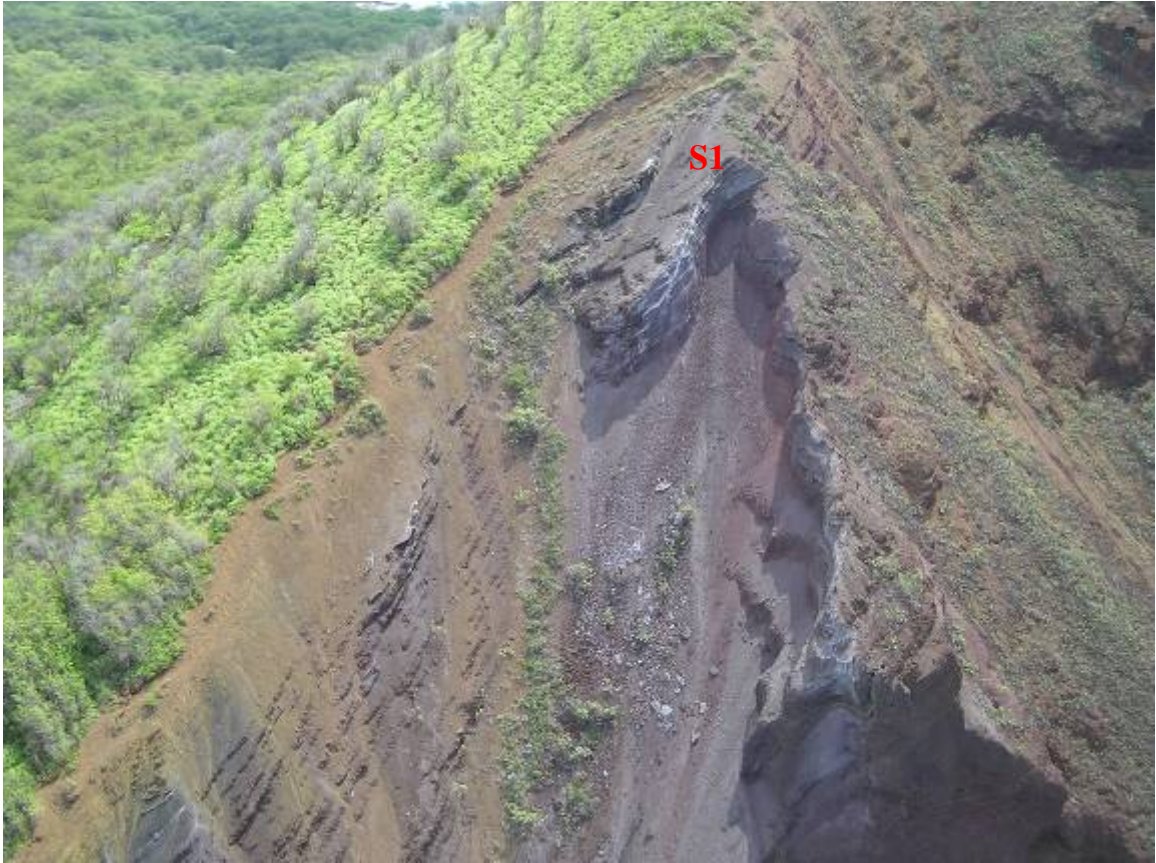
All rockfall sources are parts of Pu'u Ola'i volcanic cinder cone at Makena State Park. Photo 3 shows close view of rockfall sources close to S1 as shown in Photo 1. Photo 4 shows close view of rockfall sources S2, S3, and S4 together with unstable loose cinder blocks perched on steep slope. Photo 5 shows close view of rockfall source S5 and rockfall debris piles on the beach. Wave erosion has removed most of the debris (Photo 6). Photo 7 shows close view of rockfall sources S6 and S7. Photo 8 and Photo 9 show close views of rockfall sources S8 and S9 respectively as shown in Photo 2 at Big Beach.

- 1) Significant loose cinder debris (Photo 3) and loose cinder blocks or boulders (Photo 4, Photo 7 and Photo 12) currently exist on the steep slope with slope angle close to the angle of repose (the steepest angle at which loose fragments will stand without sliding or rolling downhill).
- 2) Hard cinder layers on top of soft cinder layers have significant overhangs and tension fractures due to the differential erosion of the soft layers (Photo 13 and Photo 14).
- 3) Relatively large sizes of slope failures may occur along fault zones (Photo 15) and large tension fractures (Photo 5).

Photo 3. Close view of rockfall sources close to S1 as shown in Photo 1, Black Sand Beach, Makena State Park.

Periodic scaling can significantly reduce rockfall hazards at Black Sand Beach. Scaling will remove the loose boulders and hazardous debris (Photo 3, Photo 4, Photo 7, and Photo 12) and the well fractured blocks in the hard cinder layers (Photo 4). Rock bolting may be used to stabilize large pieces of the hard cinder layers if such pieces are encountered. Scaling of the loose cinder layers should remove overhangs (Photo 17), fractured large blocks (Photo 5), and unstable cinders on slope faces steeper than the angle of repose. The approximate cost of first round of scaling is about \$200,000, with much lower cost for later rounds at about every five years.

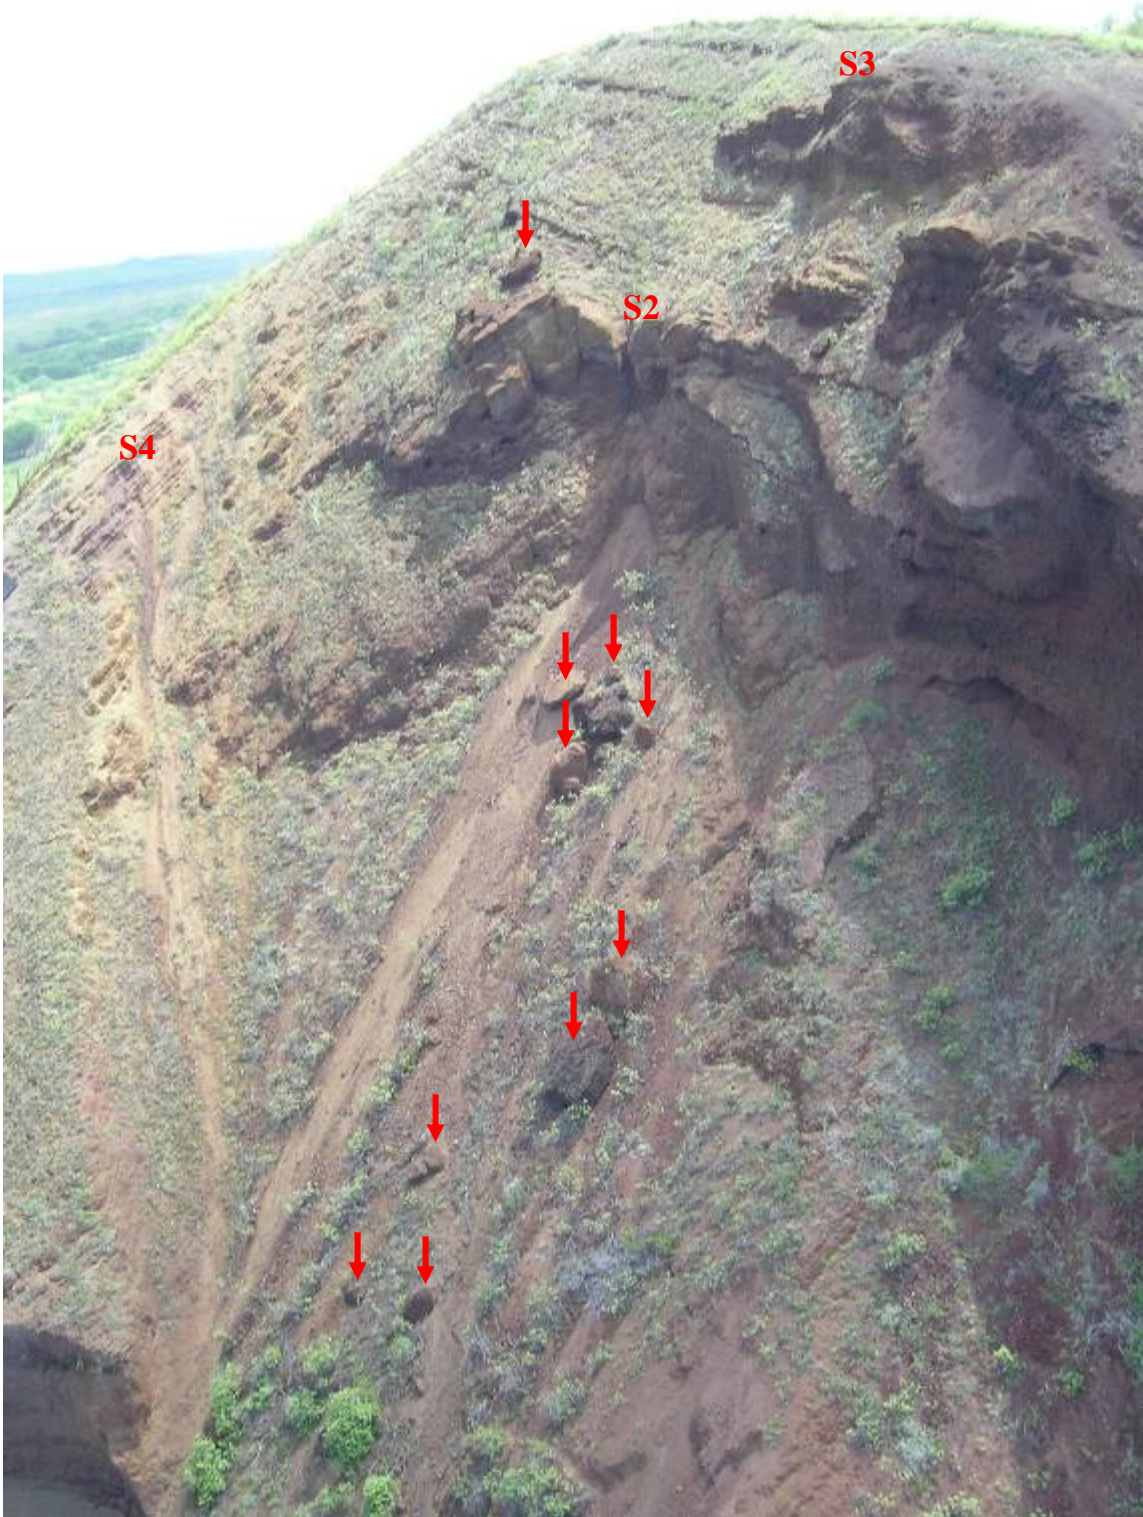
Photo 4. Close view of rockfall sources S2, S3, and S4 as shown in Photo 1. The arrows point to unstable loose cinder blocks perched on steep slope. Black Sand Beach, Makena State Park.

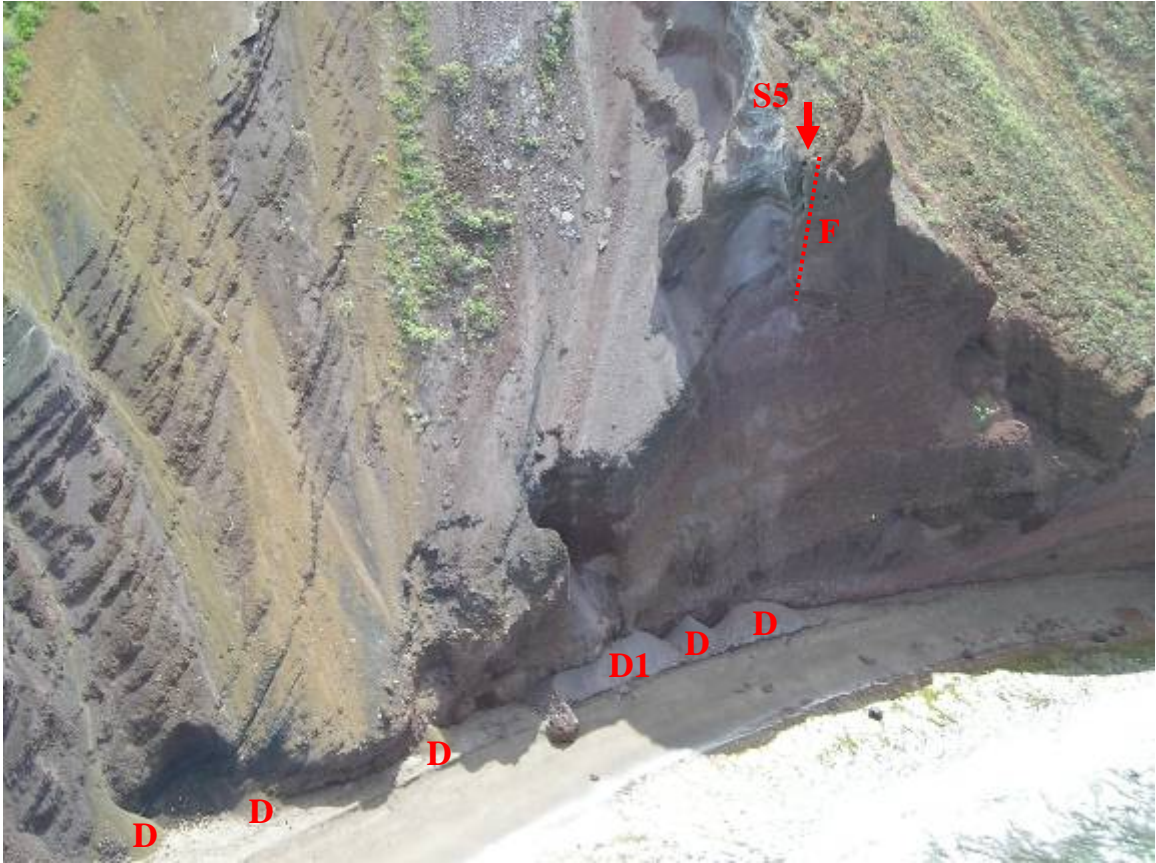
Photo 5. Close view of rockfall source S5 as shown in Photo 1 and rockfall debris piles (indicated by D) on the beach. Notice the vertical tension fracture (along the dashed line and pointed by the arrow). Black Sand Beach, Makena State Park.

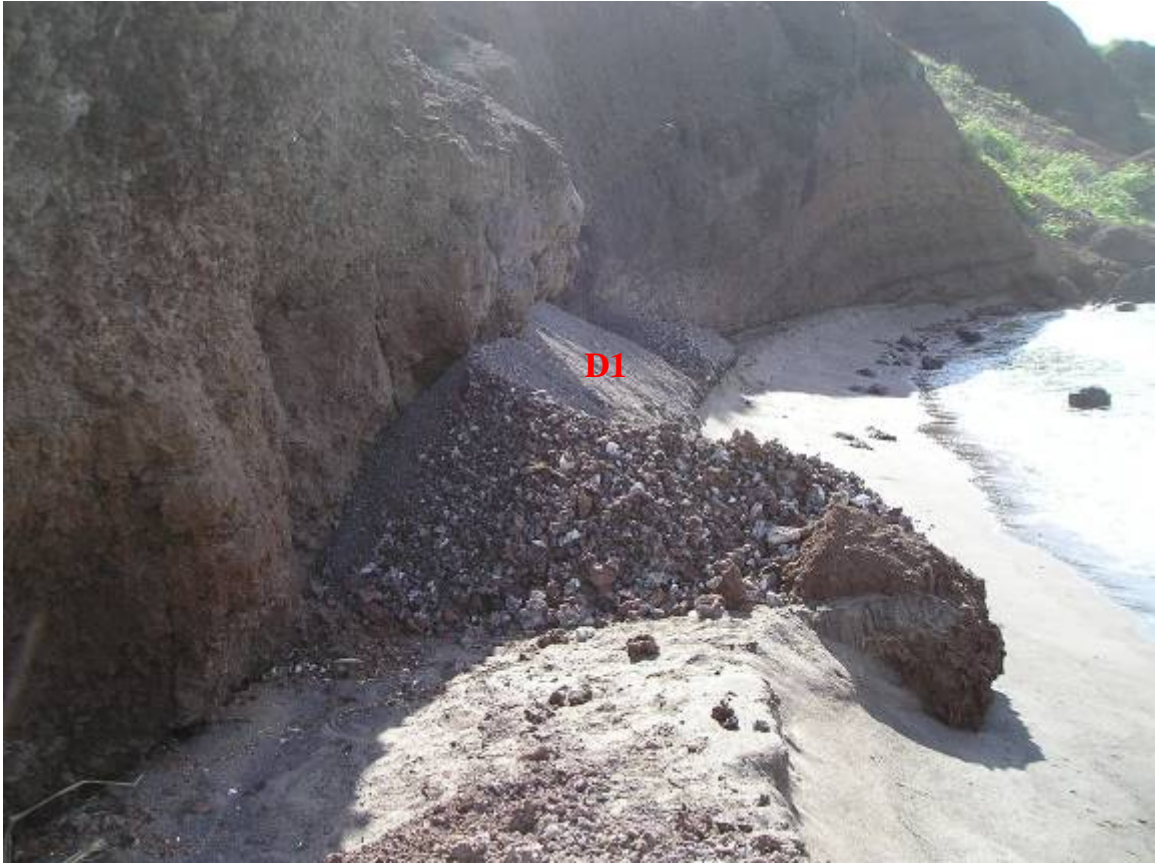
At Black Sand Beach, the narrow beach could easily be covered by rockfall debris of small loose cinders (Photo 6) and large cinder blocks (Photo 10). There is no safe zone on the narrow beach in case of rockfalls at Black Sand Beach. Some large cinder blocks could even go over 40 feet into the water (Photo 10).

Photo 6. Close view of rockfall debris pile D1 as shown in Photo 1 and Photo 5. Notice wave erosion has removed most of the debris. Black Sand Beach, Makena State Park.

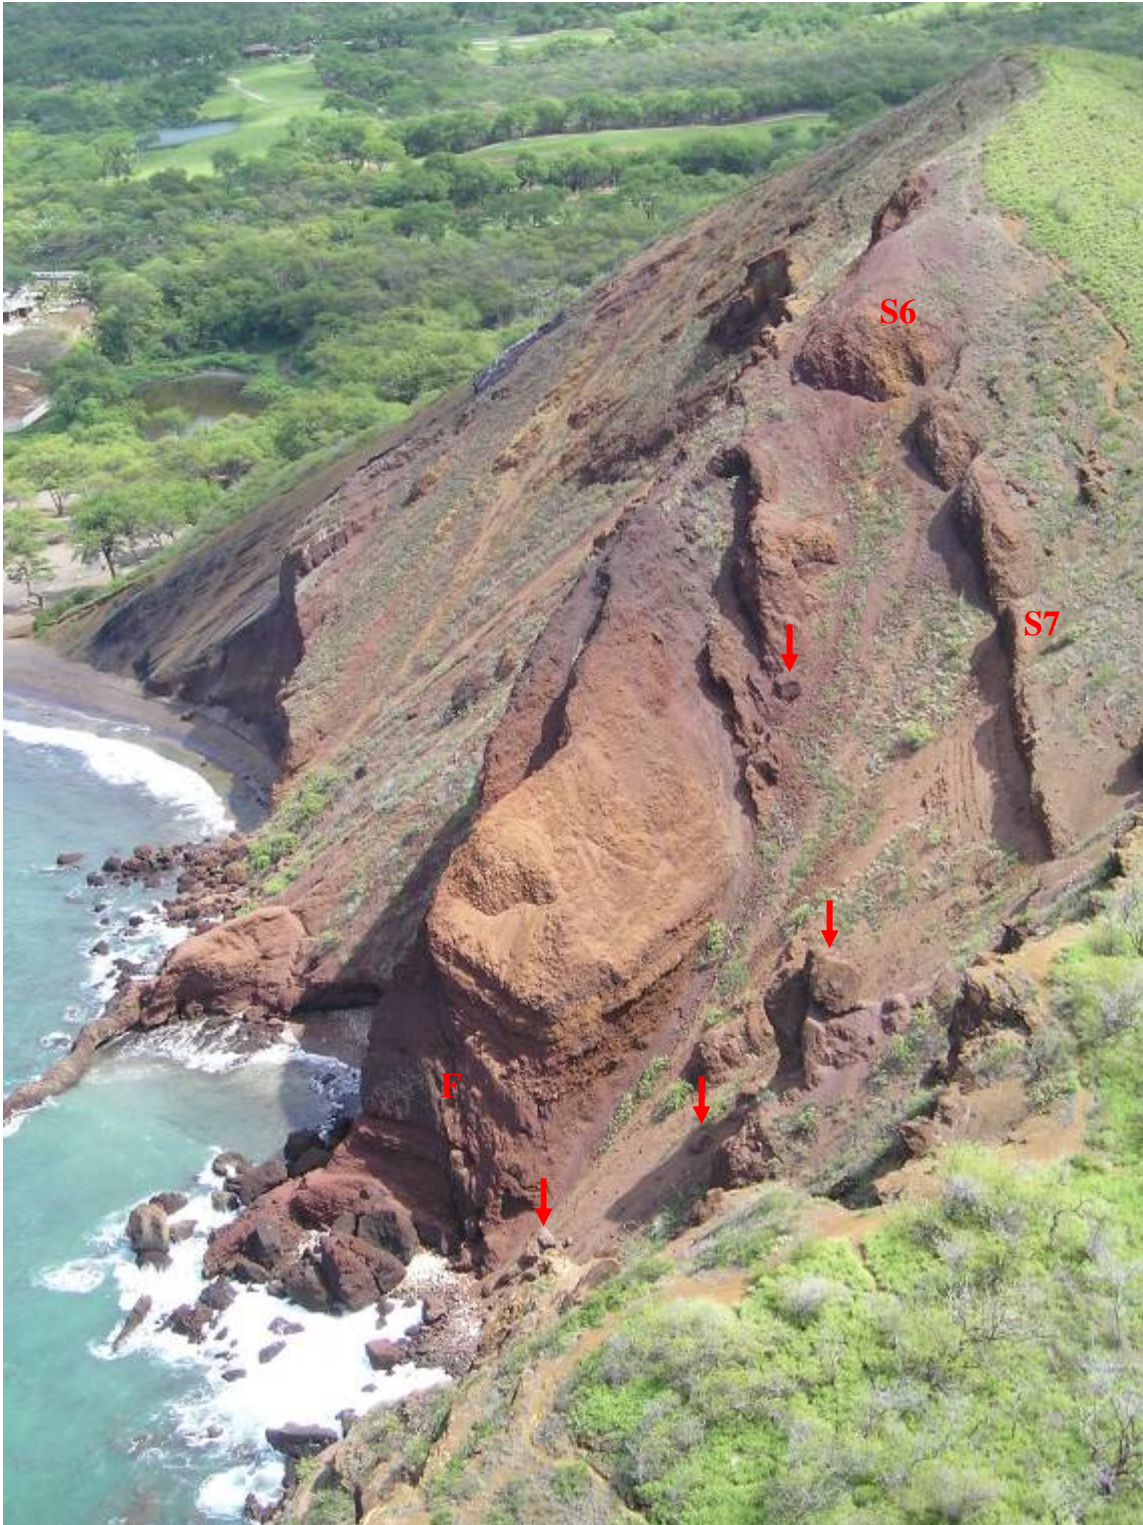
Photo 7. Close view of rockfall sources S6 and S7 as shown in Photo 1. The arrows point to unstable loose cinder blocks. Black Sand Beach, Makena State Park.

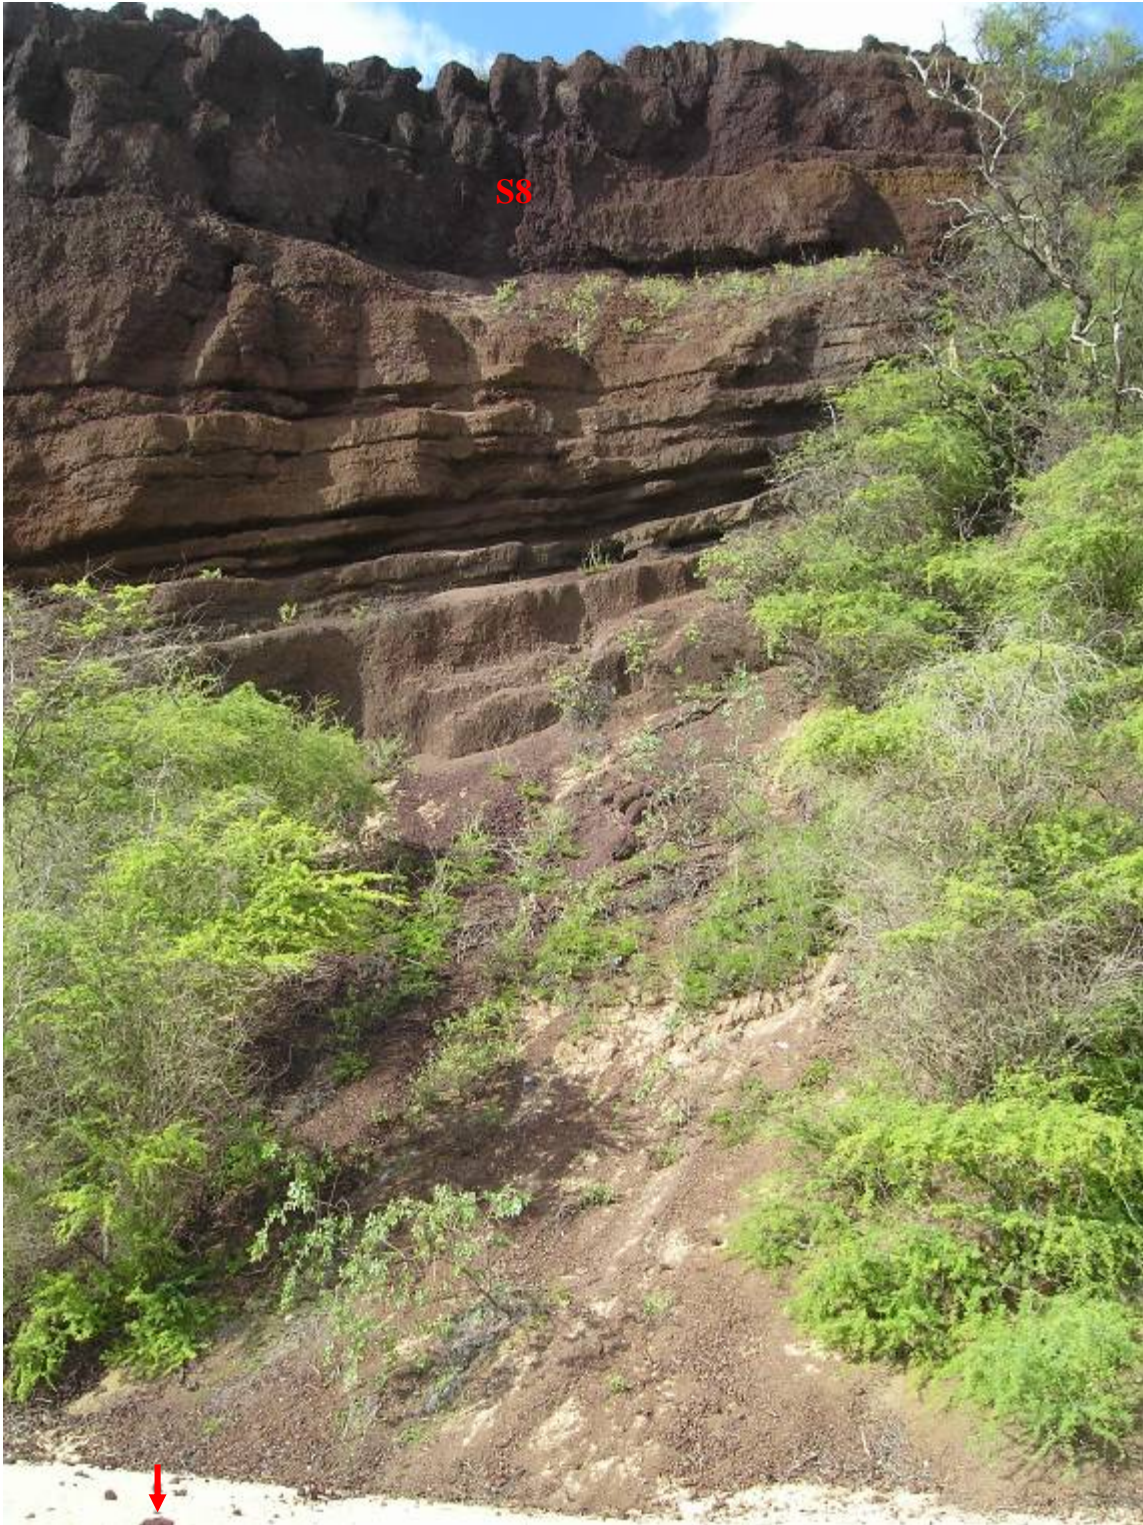
Rockfall hazards at Big Beach include a few loose boulders, the weak veneer layer (Photo 9), and the fractured and overhang hard cinder layers (Photo 8, Photo 18 and Photo 20). The rate to produce new rockfalls in the hard cinder layers at Big Beach is much slower than that in the loose cinder layers at Black Sand Beach.

Photo 8. Close view of rockfall source S8 as shown in Photo 2. The arrow at left bottom of photo points to a rockfall debris on the white sand beach. Big Beach, Makena State Park.

For Big Beach, scaling and optional limited demolition and bolting are recommended. Scaling will remove the loose boulders and hazardous loose debris (Photo 9) and well fractured rocks (Photo 8). Demolition may be used to remove hazardous overhangs if they cannot be removed by scaling (Photo 18). Rock bolting may be used to stabilize large pieces of the hard cinder layers (Photo 20) if their rates of settlement increase with potential for toppling failures. During construction, only small portions of Big Beach need to be closed. The cost of scaling with optional limited demolition and bolting is approximately \$100,000.

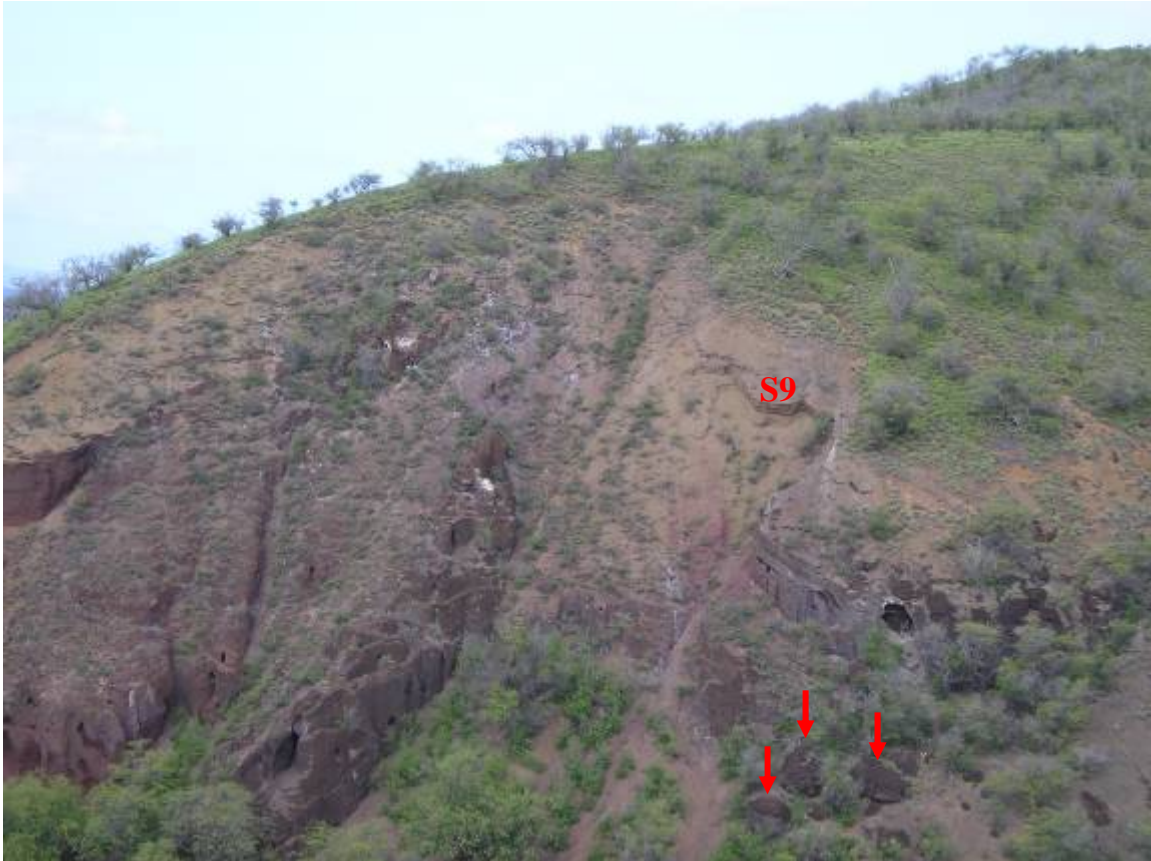
Photo 9. Close view of rockfall source S9 as shown in Photo 2. The arrows point to unstable loose cinder blocks perched on steep slope. Notice S9 is a steep-dipping veneer cinder layer covering the gentle-dipping cinder layers shown in Photo 8. Big Beach, Makena State Park.

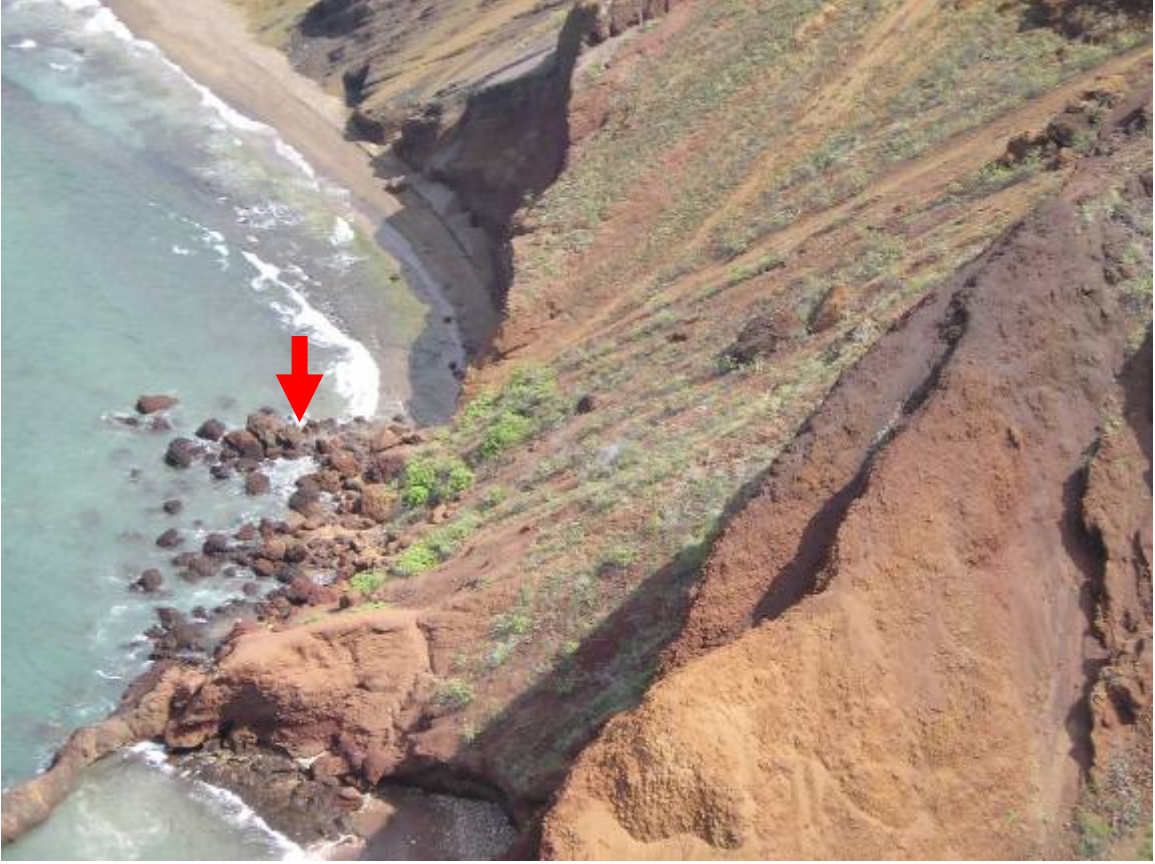
Photo 10. Rockfall debris of large cinder blocks (indicated by the arrow) at Black Sand Beach, Makena State Park.

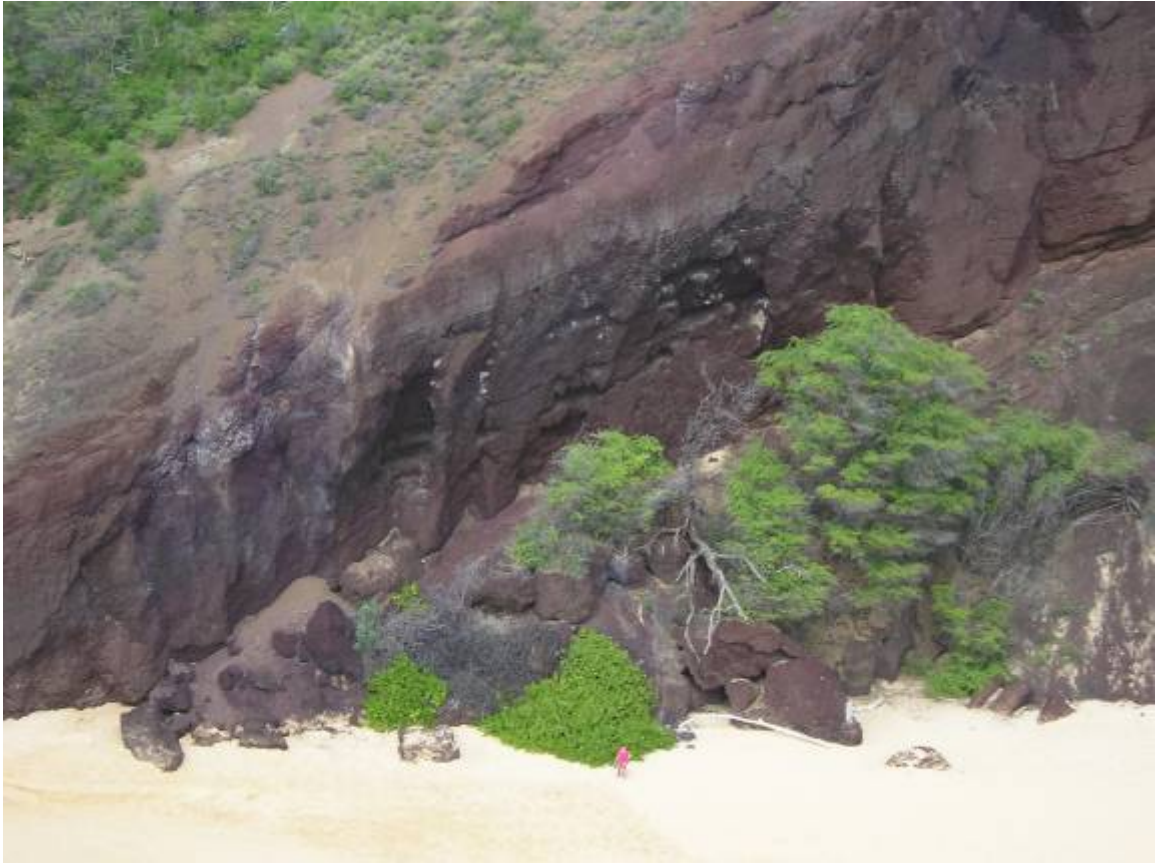
Photo 11. Fallen boulders from the near vertical cliff stopped close to the cliff. Big Beach, Makena State Park.

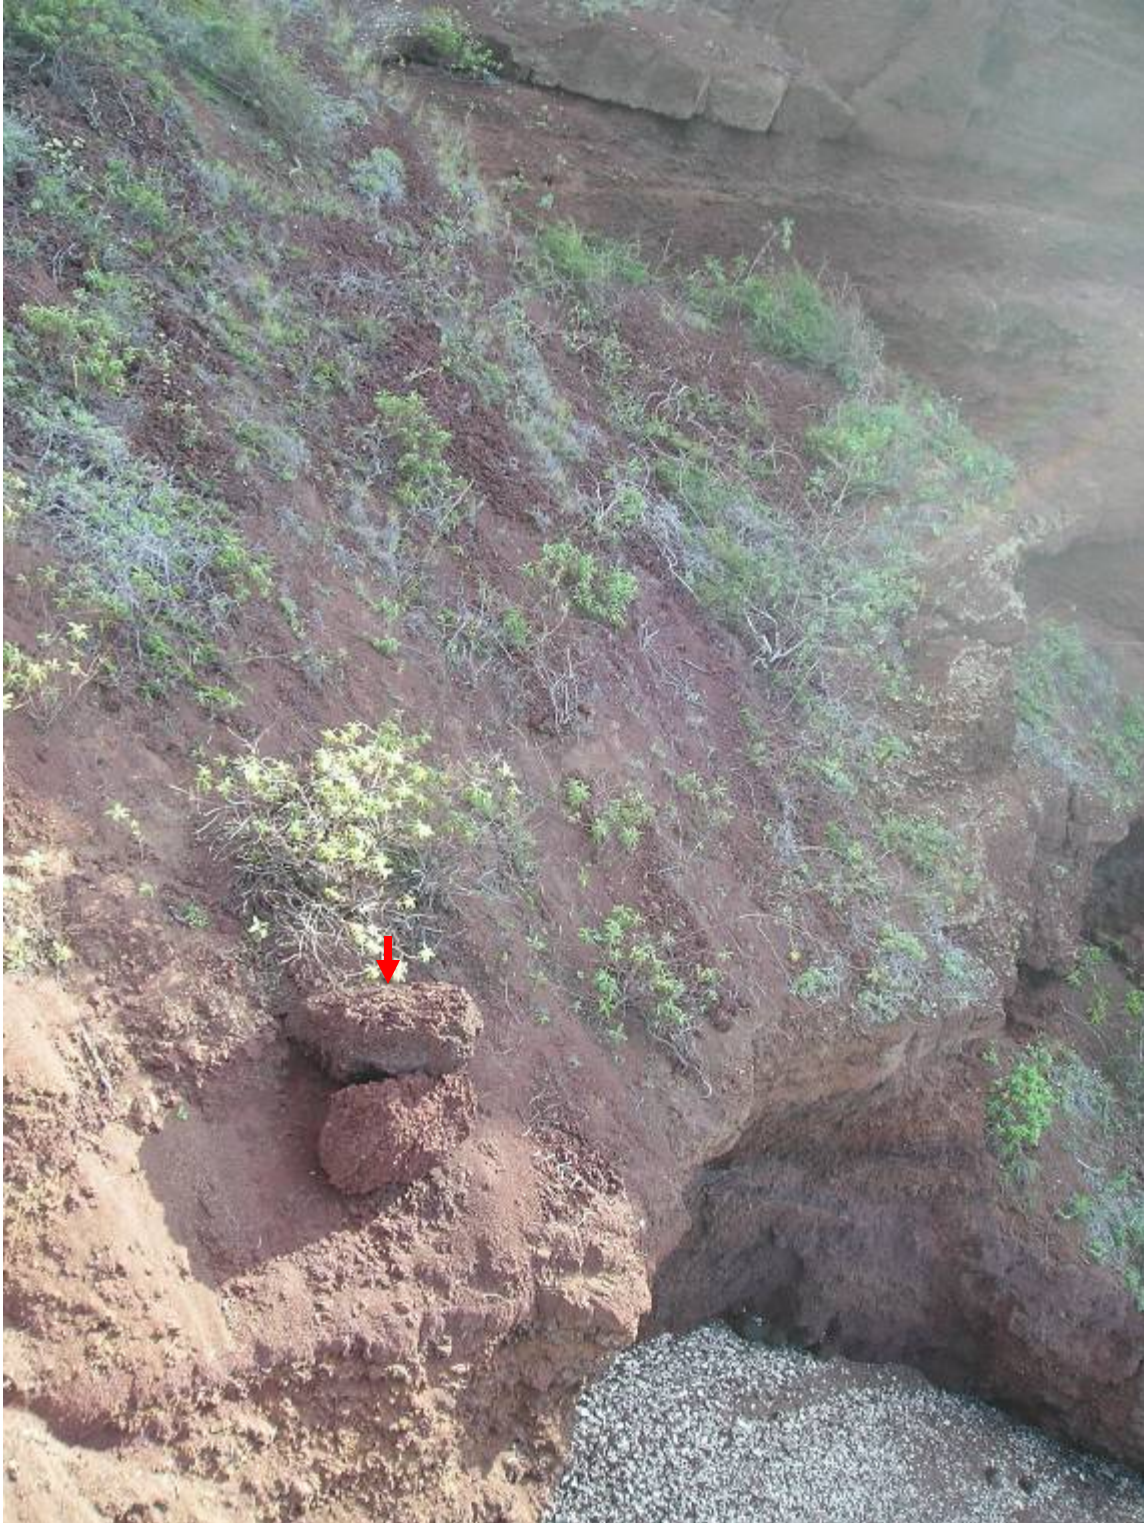
Photo 12. Loose cinder blocks (indicated by the arrow) perched on the steep slope at Black sand Beach, Makena State Park.

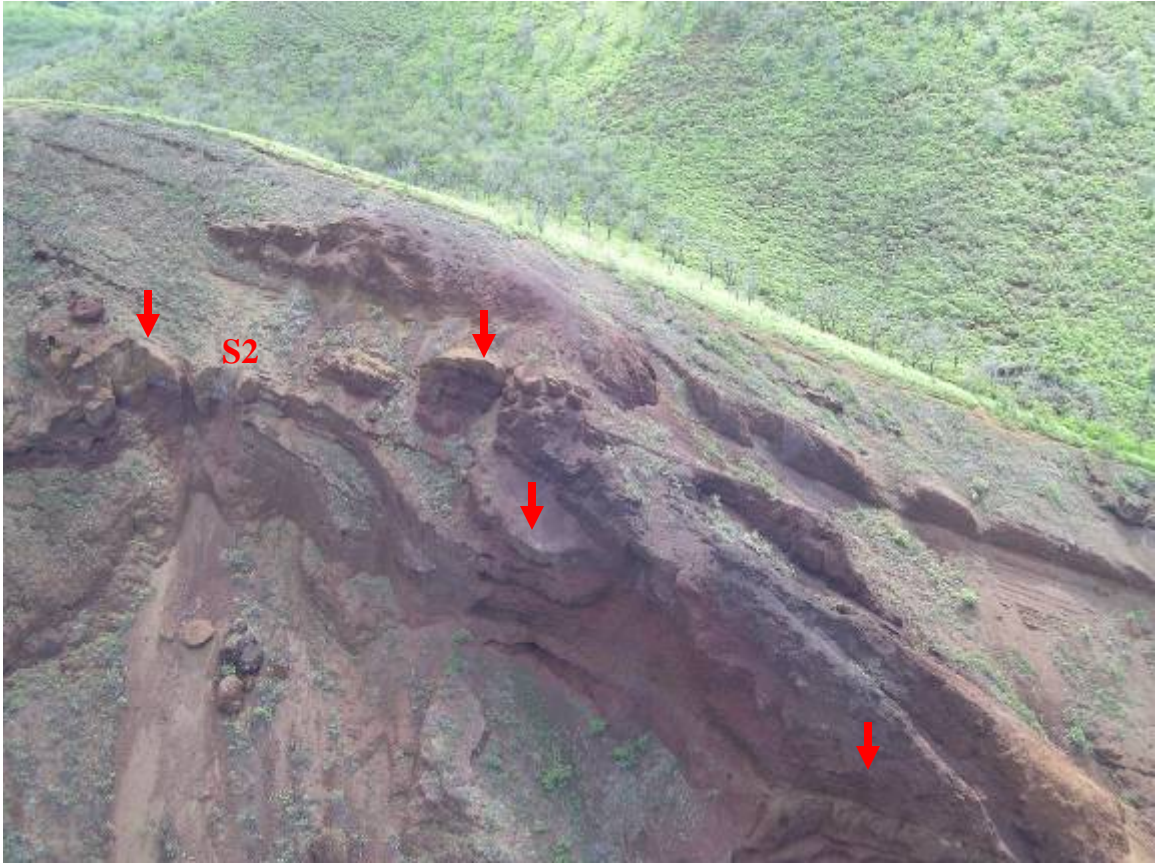
Photo 13. Hard cinder layers (pointed by the arrows) develop significant overhand and tension fractures due to the differential erosion of soft layers underneath. Black Sand Beach, Makena State Park.

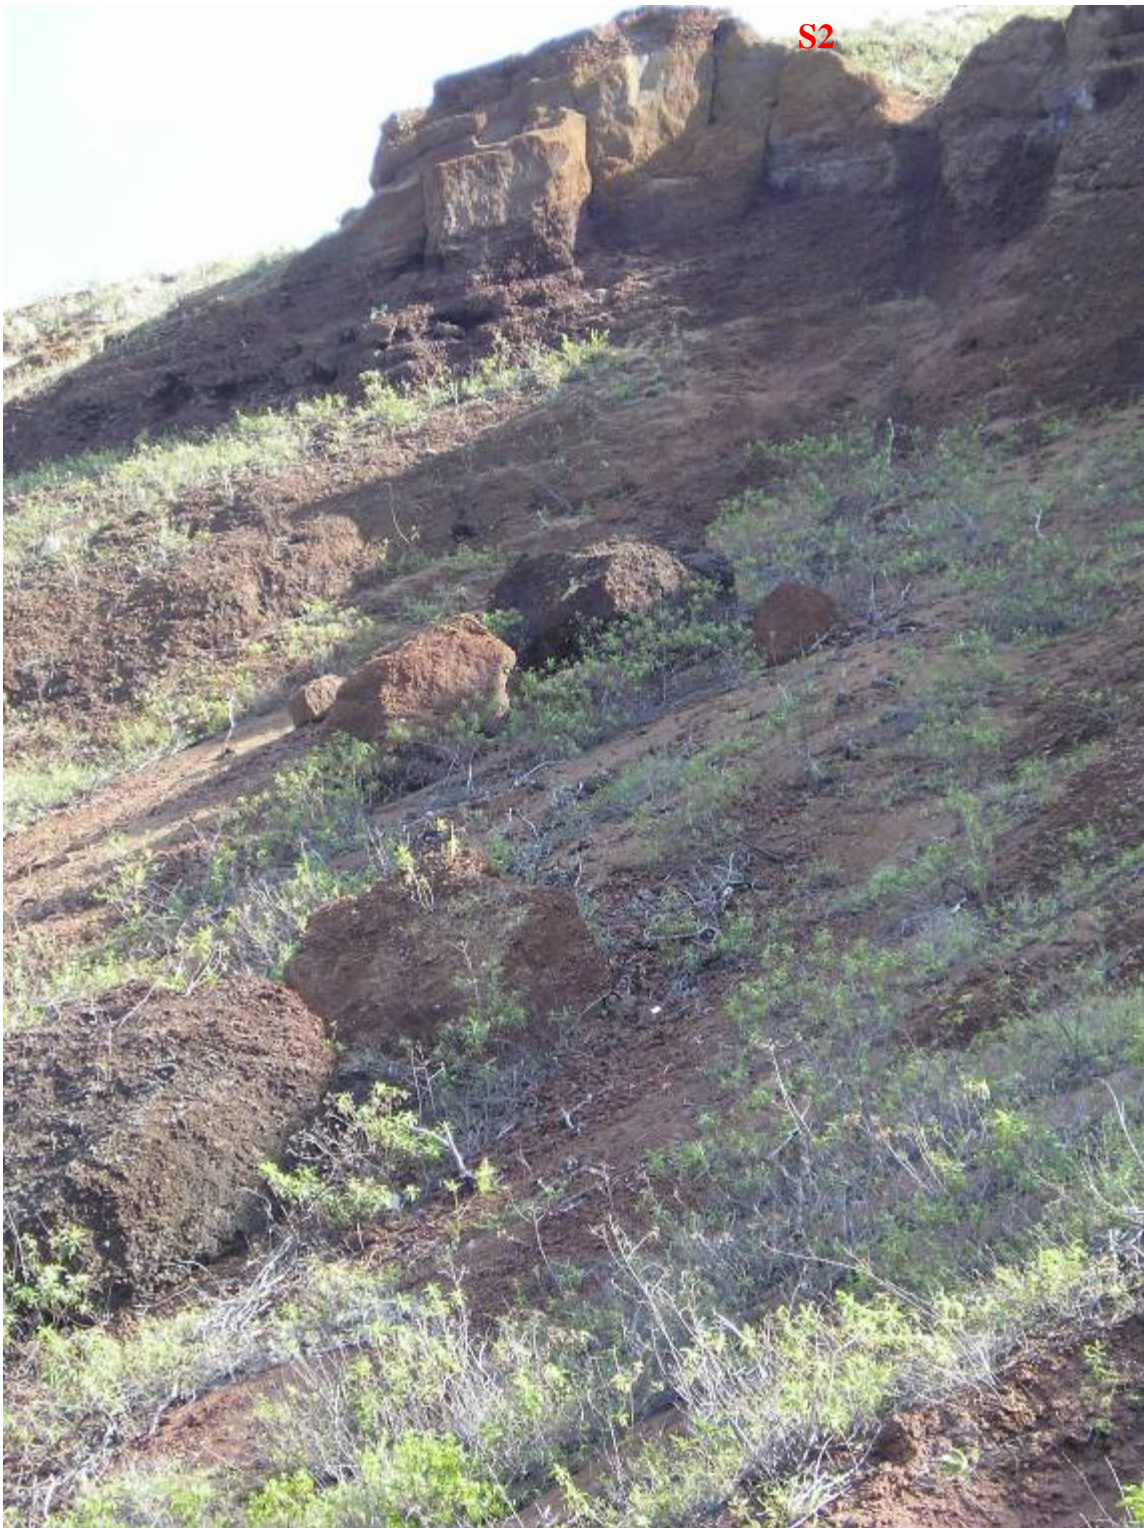
Photo 14. Detail of Photo 13 showing hard cinder layers sitting on top of soft cinder layers with well-developed tension fractures. Black Sand Beach, Makena State Park.

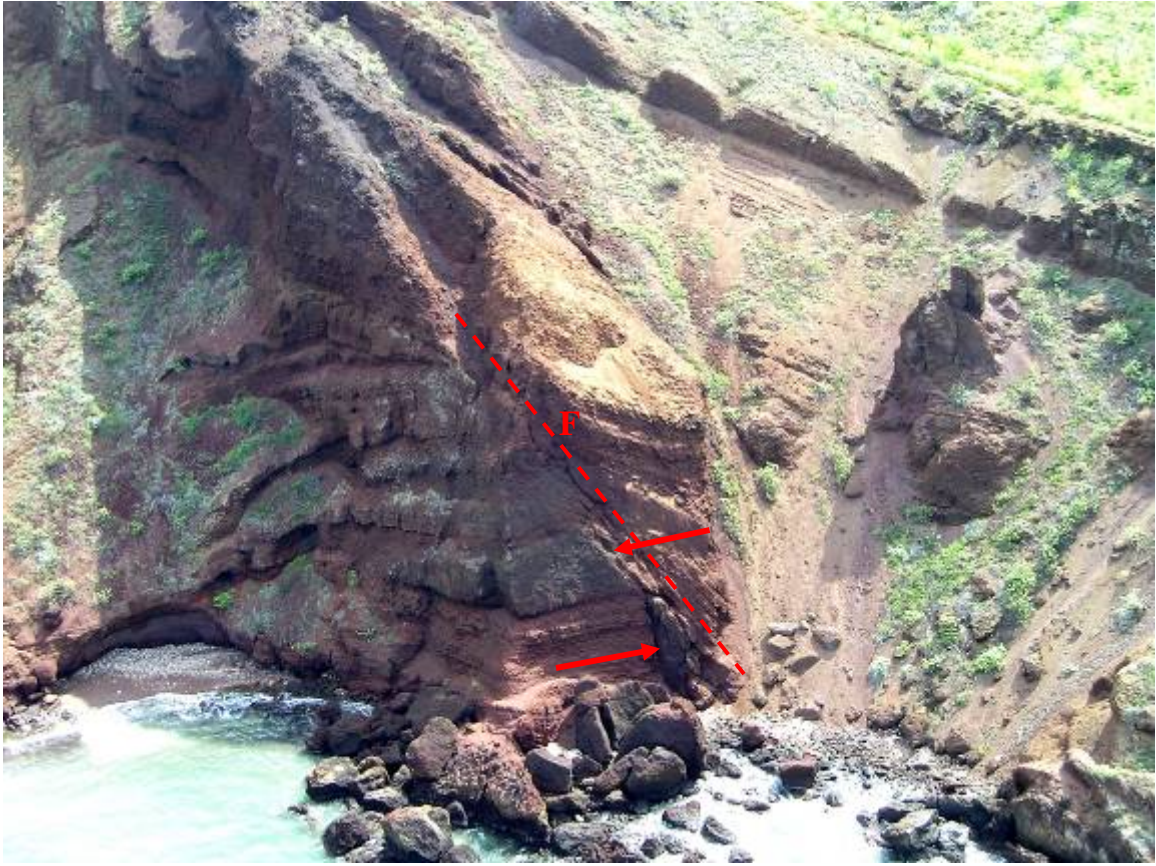
Photo 15. A fault zone (indicated by the dashed line). The two arrows indicate the dislocation of one cinder layer; the dislocation along the fault zone is larger. Black Sand Beach, Makena State Park.

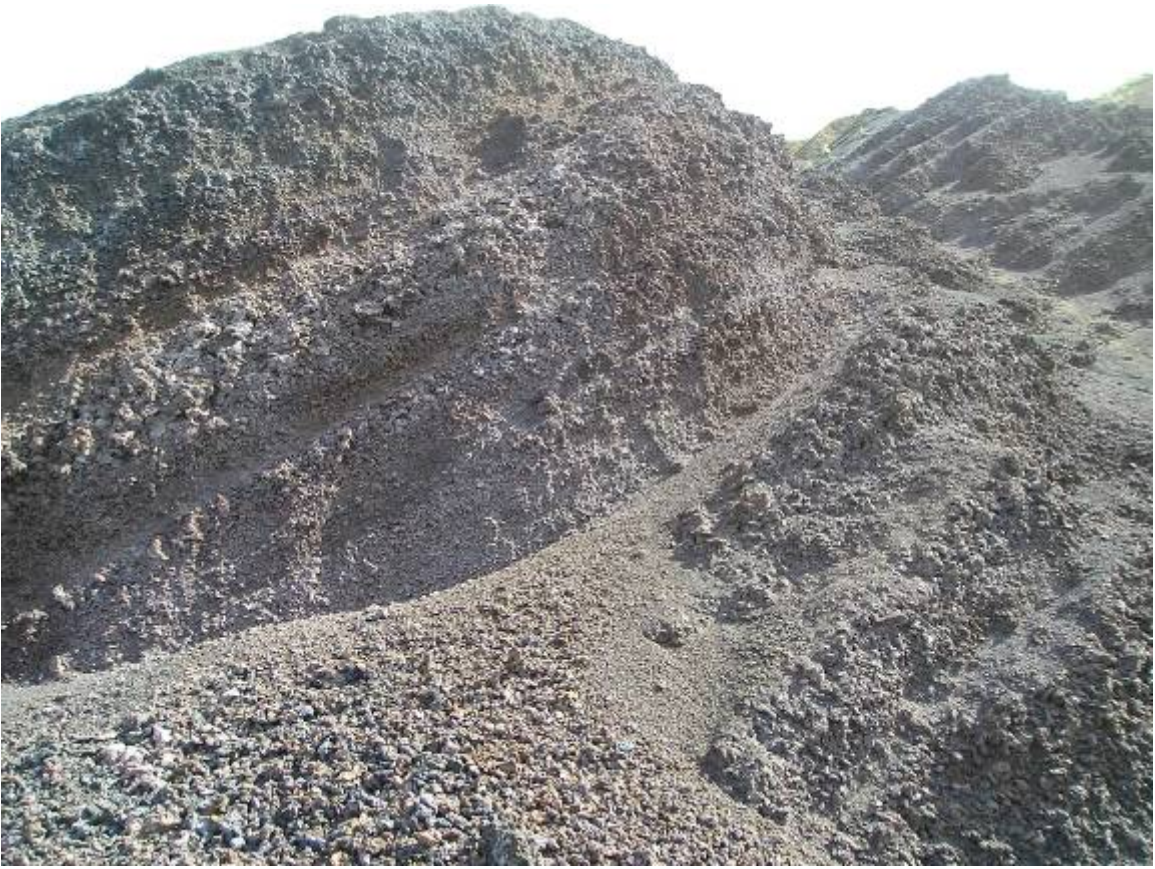
- 4) Falling of egg-sized (or larger) cinders onto the beach will be pervasive (Photo 17) as most cinder layers at Black Sand Beach are loose with poor cementation (Photo 16).

Photo 16. Very loose cinder layers with poor cementation. Black Sand Beach, Makena State Park.
